**DEVELOPMENT OF COMPRESSOR END SEALS
STATOR INTERSTAGE SEALS, AND STATOR PIVOT SEALS
IN ADVANCED AIR BREATHING PROPULSION SYSTEMS**

PART II

**PRATT & WHITNEY AIRCRAFT
EAST HARTFORD, CONNECTICUT**

**NASA LEWIS RESEARCH CENTER
CONTRACT NAS3-7605
Cleveland, Ohio
L.P. Ludwig, Project Manager**

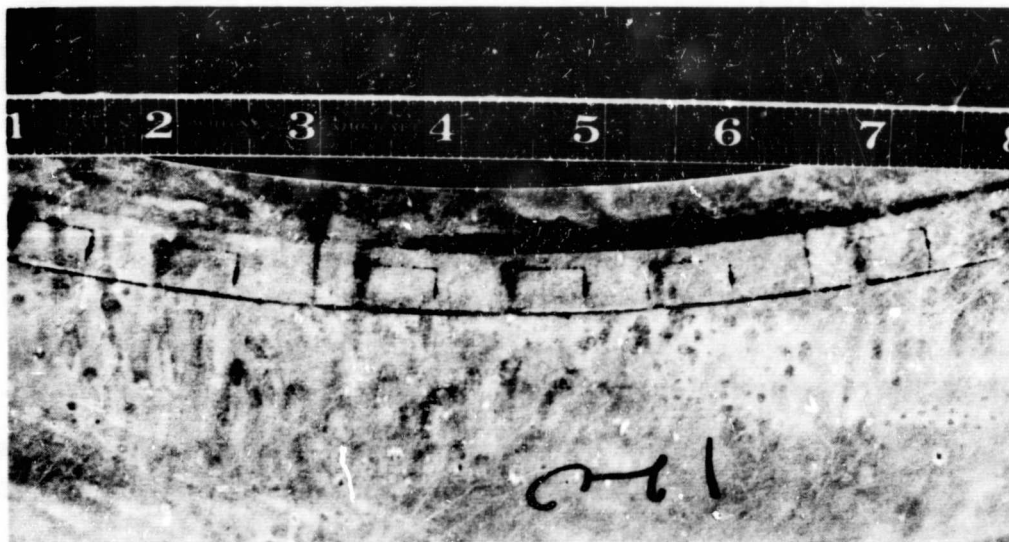
The seal was removed from the fixture and disassembled. As shown in Figure 6, dust imprints of the shoe seal segments were clearly outlined on the fixture, with a heavy concentration about the outer edge. These dust imprints confirmed that the shoes were tilting in such a manner that a gap was created between the inner edge of the shoes and the seal runner.

Figure 6 Dust Imprints on the Seat from the One-Side Floated-Shoe End Seal (CN-16704)

To alleviate the tilting, a segmented thrust ring was fabricated to replace the one-piece ring formerly in use (see Figure 34, p. 27). The new segments allowed the beveled thrust rings to align themselves with greater precision. This change also allowed the spring radial load component against the shoe to be directed more positively toward the two secondary seal pads. In addition, eight low pressure vent holes were added to the existing three low-pressure

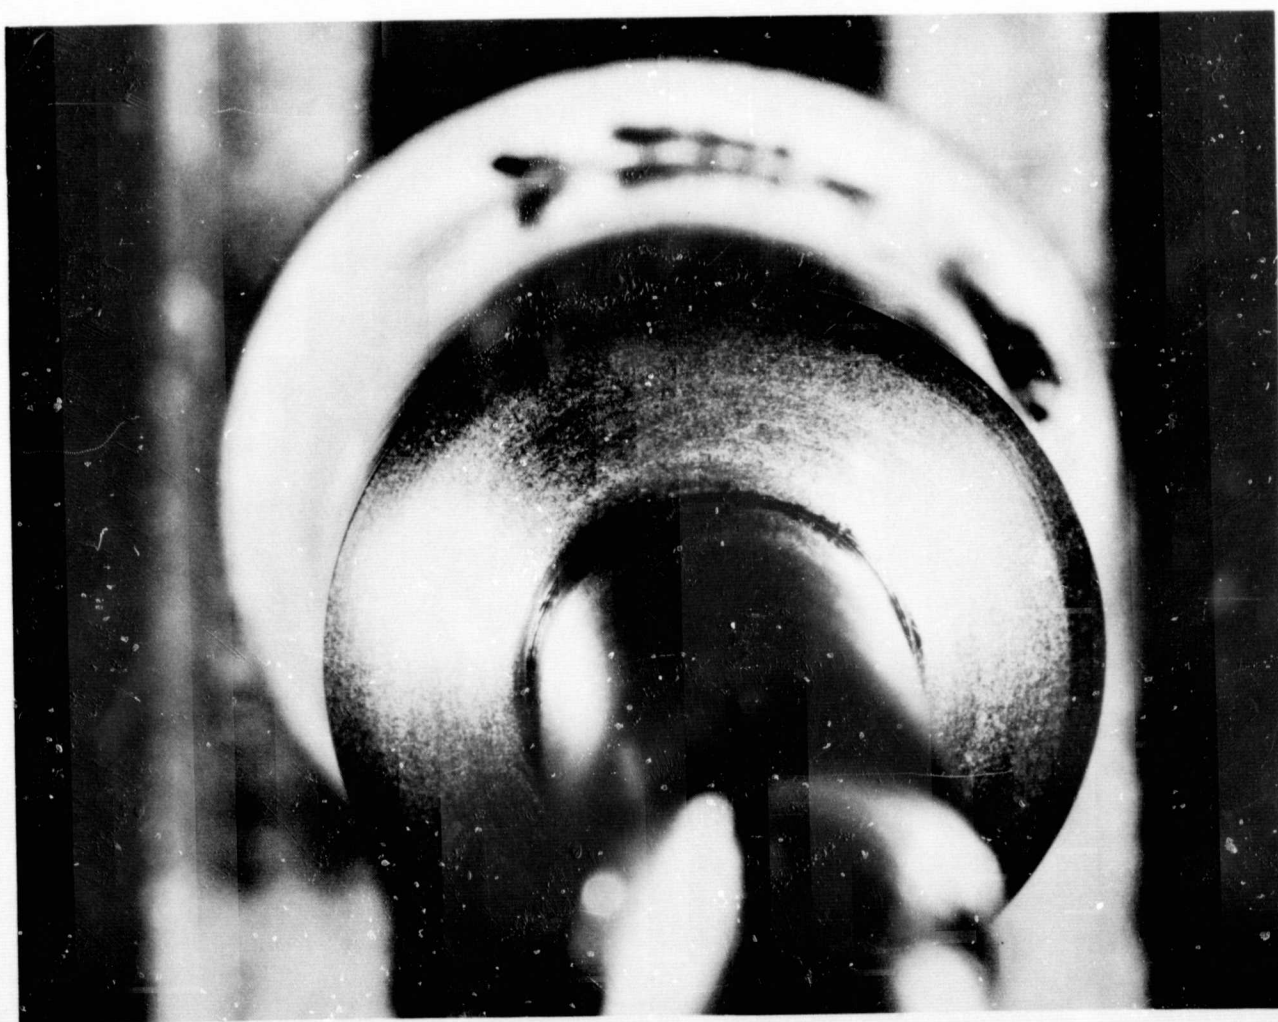
Figure 152 Condition of Hardface Seal Surface of Test Unit 5 Before Test (XP-92618)
